# A COSTLY RESTORATION IS AVOIDED WITH GE ENDURIS\* ROOF COATING

NMA Corporate | Broek op Langedijk, Netherlands

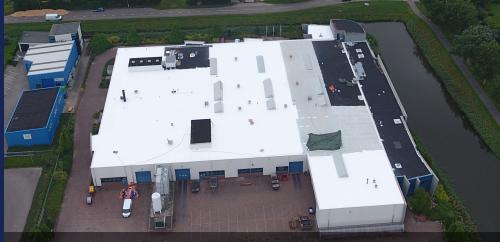
The white Enduris coating reflects solar rays, which resulted in a 3–5% better yield for solar panels positioned on the roof.

NMA selected a white color for the GE Enduris coating, which resulted in a noticeably increased yield from the organization's rooftop solar panels, due to the newly reflected sunlight. It also resulted in less wear and tear from extreme daily temperature fluctuation, by allowing the roof's peak temperature to be up to 63°F (35°C) lower on an average summer day. This also meant significant savings on summer cooling energy compared to a black roof. "It was a smart decision that will give us a lasting return year after year," said Baaijens. "We were impressed with the ways GE Enduris roof coating brought extra benefits and longevity to our building."
